RAIL INVESTIGATION REPORT

**Collision between the passenger  
train 5AL8 and vehicles at the  
Salisbury Interchange level crossing,  
Salisbury, South Australia**

**24 October 2002**

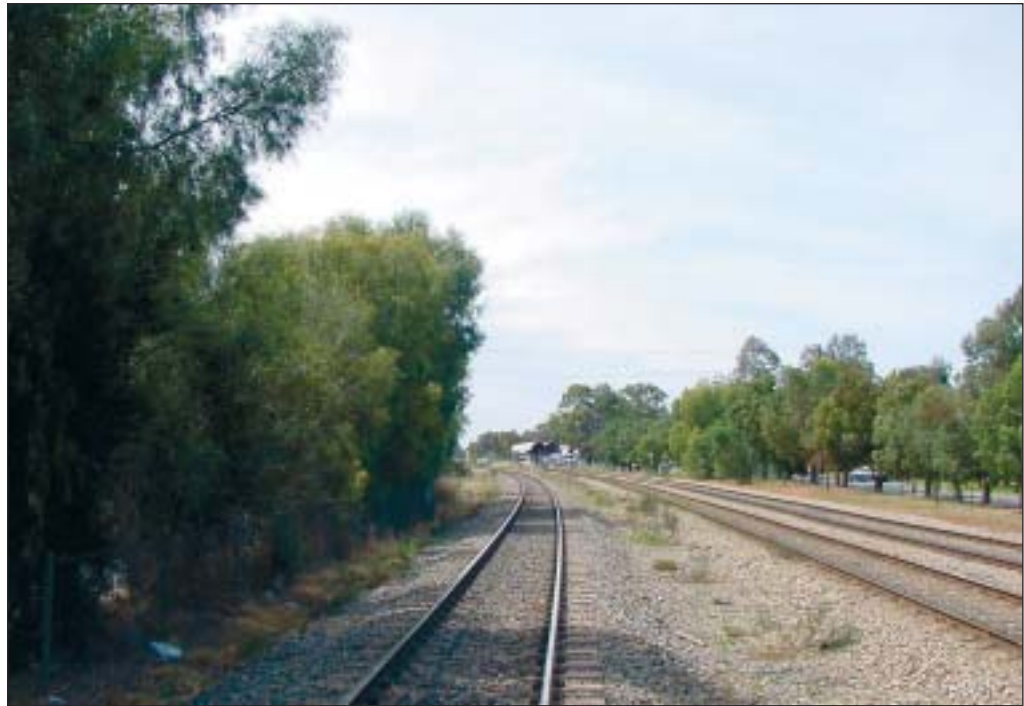
**FIGURE 3:**  
**Rail approach to Park Terrace**

At about 15:32:45, about 330 m from the crossing, the train drivers saw Salisbury Station and the traffic waiting at the right side (eastern) approaches to the crossing at the boom barrier. In the next seconds, as the locomotive continued to round the curve, it appeared to the driver that there might be two cars between the broad gauge and standard gauge tracks.

As the driver of train 5AL8 reached for the warning horn, the left side of the crossing came into view at about 250 m and he saw a white car and a bus apparently parked overlapping the outer running rail. With the warning horn sounding at 15:32:49, the driver simultaneously gave an exclamation. One second later, at 15:32:50, he applied full emergency braking and also put the independent brake to full application. At 15:32:51 the throttle was put from 'notch 8' (maximum power) to idle. The second driver said words to the effect 'I hope this traffic is going to move!'

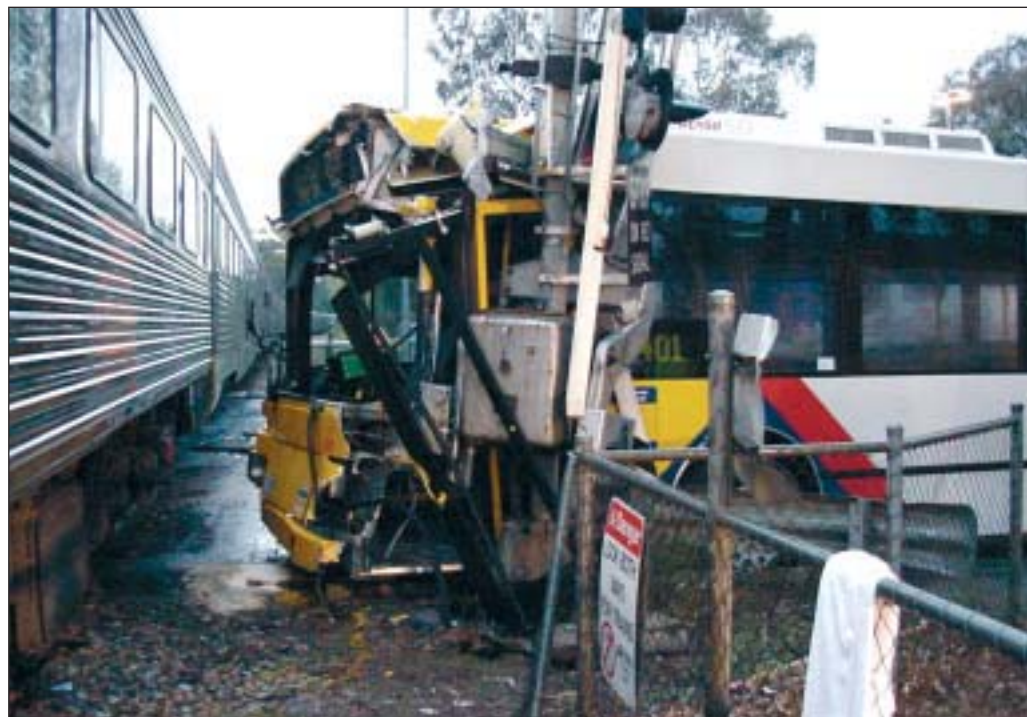
**FIGURE 4:**  
**The bus**

The bus involved was part of the Serco Bus fleet, number 246, registration number VYV 786, model number NL202D, MAN with an overall length of 11.7 m and a width of 2.445 m. The damage was such that the bus was not repaired.

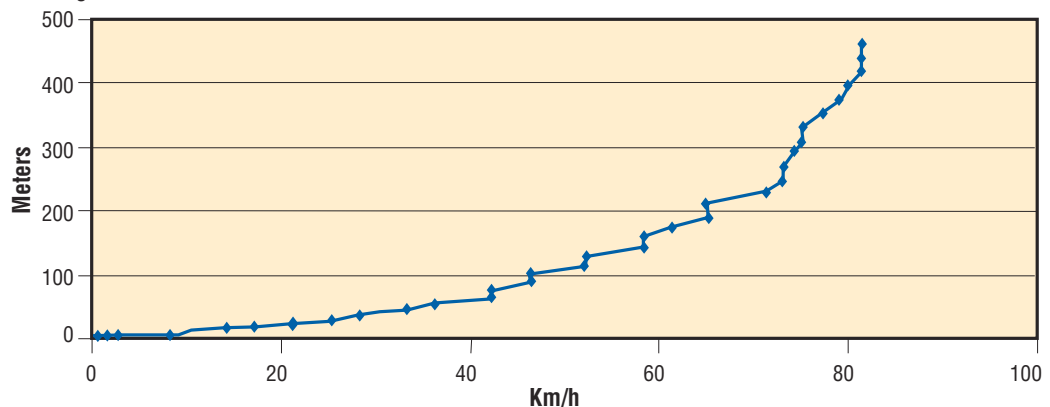
**FIGURE 6:**  
**Braking distance 5AL8 24 October**

Given the sighting distance of about 250 m the chances of train 5AL8 or a train of greater mass having sufficient time to come to a halt before Park Terrace crossing is problematic. Allowing for assessment and reaction time by a driver, a driver would have at best 200 m in which to bring a train to a halt. The braking characteristics of a train will vary, but is largely a function of mass, speed and the gradient. The difference between the 600 m passenger train and an 1800 m freight train is significant. Train 5AL8 would have stopped just short of the crossing had its initial speed been 70 km/h. However a 1800 m freight train pulling 5860 tonnes could only travel at 40 km/h to achieve a stopping distance of 250 m.

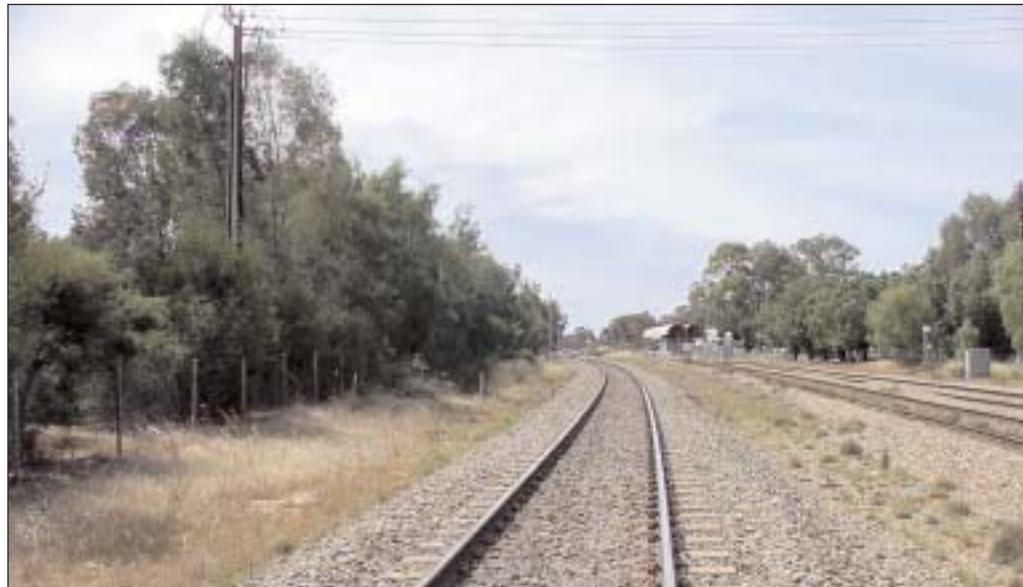
**FIGURE 7:**  
**Park Terrace at about 250 m**

The real effect of limiting the train speed to 50 km/h is that a road vehicle or pedestrian has more time to clear the line than if a train is travelling at 80 km/h. A sighting distance of 250 m provides an extra seven seconds for road vehicles and pedestrians to clear the tracks. This time would be greater if the approaching train applied full emergency braking.

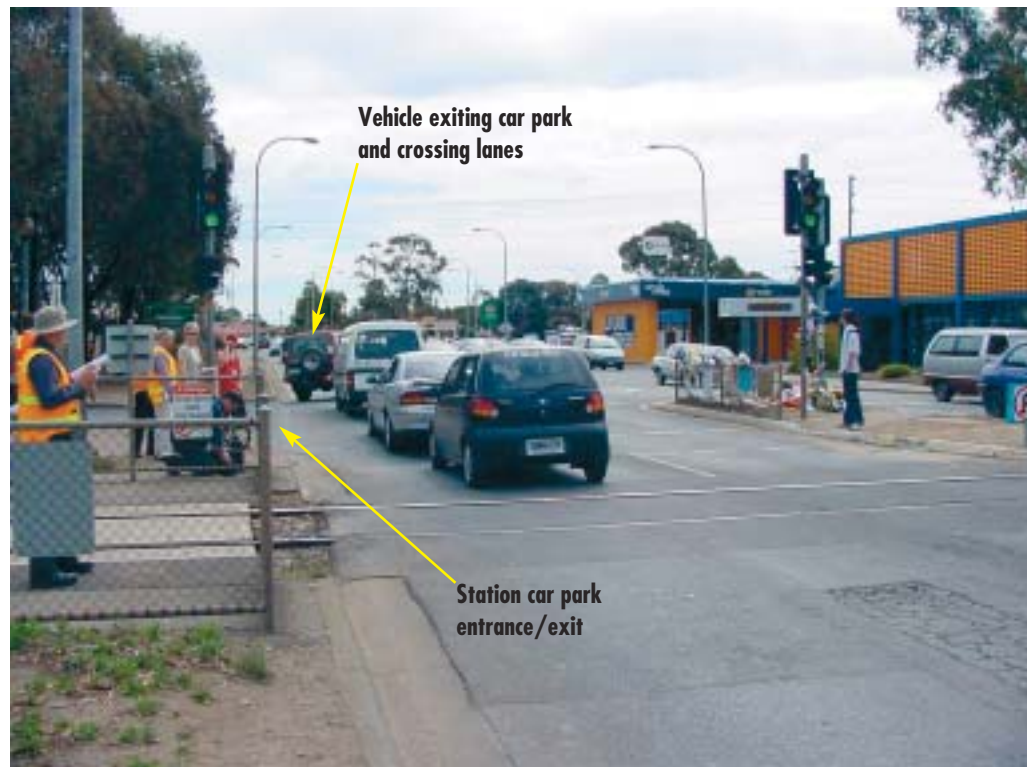
**FIGURE 8:**  
**Park Terrace crossing**

The Park Terrace crossing, from the eastern stop line to clear the pedestrian crossing on the west side, is 30 m (about 22.5 m from the boom barrier to one metre clear of the track). A car travelling at minimum speed, say 5 km/h, should travel some 40 m. By 15:32:40 the traffic had come to a complete stop so that vehicles were queued back with two vehicles foul of the standard gauge track and a further two behind them.

Prima facie at least four road vehicles did not observe the Australian Road Rules. There may be a number of factors, which it would be reasonable to assume prompted drivers to take such a risk, none of which are mutually exclusive:
